## Generic Case Studies

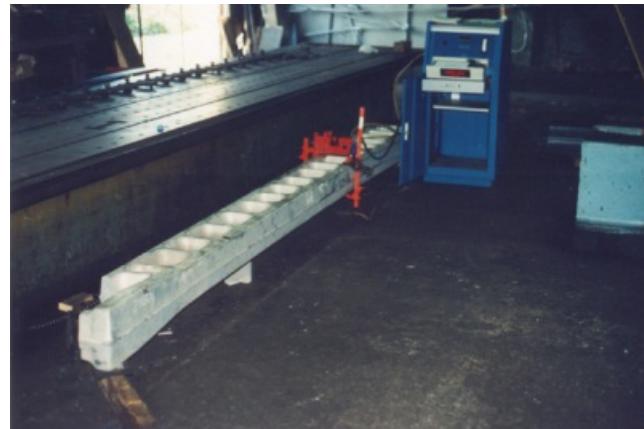
### #1 – Longerons

Description. Longerons for U.S. bombers, which connect the cockpit to the fuselage, were forgings made out of 7075 aluminum and measured 8-inch x 18-inch x 18-feet. The finished product required several extensive machining steps. Forgings started at 1,665 lbs. and finished around 600 lbs. The tolerance over the length was 0.125-inch flatness.

Normal Performance. Normal distortion always exceeded tolerance to the point that special approval was given to accept longerons with an overall distortion that was less than 0.200-inch. Even with the special approval, scrap rate was around 90 percent.

Performance After Meta-Lax Treatment. Meta-Lax stress relief was applied to one longeron (before any machining) as a trial. Longerons were machined to an overall flatness of 0.087-inch (42% better than their previous best).

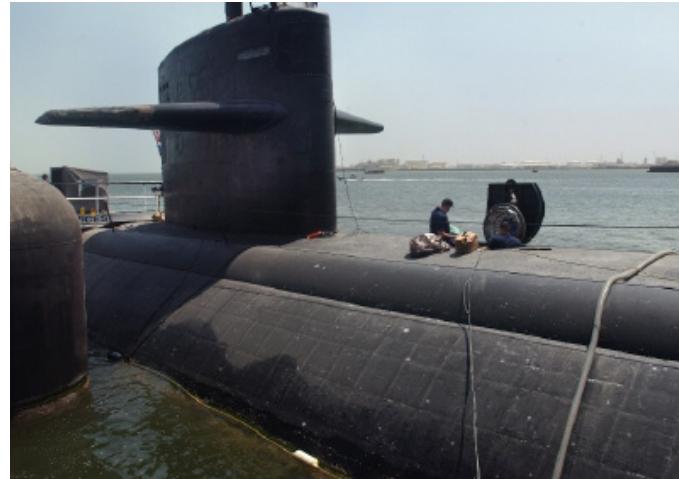
## **#5 – Fairwater Planes**

Description. A fairwater plane is the horizontal fin towards the top part of a submarine. The part is made out of HY80 steel and is hollow with tar like material filling the inside. Cracking frequently occurs and requires repair.

Normal Performance. The normal repair procedure required scarfing, preheating, and welding the cracked area. Yet reoccurring cracking within 24 hours would commonly occur. Each repair cycle would normally take 1-2 shifts plus 24 hours for cooldown. Reoccurring cracking ranged between 20 to over 45 times per fairwater plane.

Performance After Meta-Lax Treatment. Meta-Lax was applied during welding (Meta-Lax Weld Conditioning) on two fairwater planes. The first one had already been welded forty times. MLWC was applied during welding and without preheating. After the 24 hour cooldown the fairwater plane was inspected and no cracks were found. MLWC was applied to a second fairwater which had just not yet been repair weld. After the first weld repair using MLWC there was a small crack identified. Following the second weld repair of that fairwater plane no cracks were found.

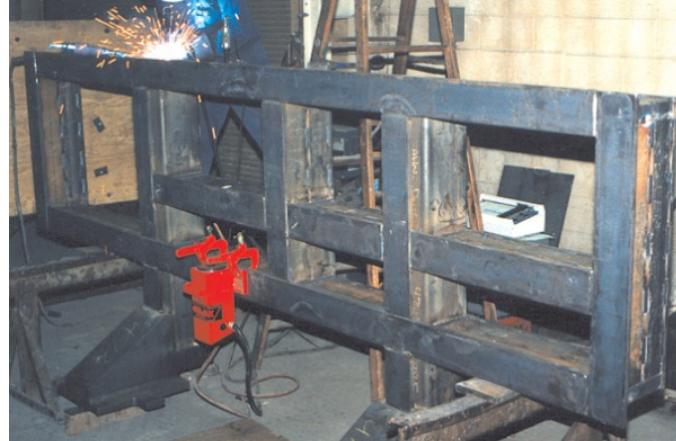
## **#6 Checking Fixture**

Description. Tubular weldment 16-feet long of 1020 hot rolled steel.

Normal Performance. Distortion from welding averaged 0.375-inch. Straightening was required to a tolerance of 0.100-inch. Distortion from machining averaged 0.010-inch.

Performance Following Meta-Lax Weld Conditioning. Checking fixture was welded using MLWC. Distortion from welding averaged 0.050-inch (80% less than normal). No straightening needed. Distortion following milling was 0.0015-inch (85% less than normal).

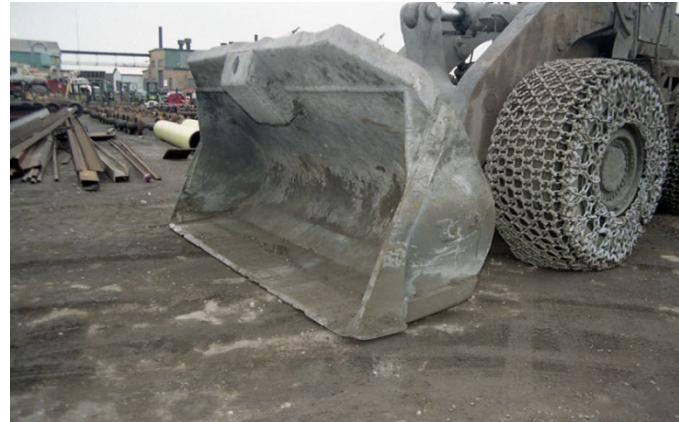
### **#7 Hough Bucket**

Description. Bucket consisted of low carbon steel bucket with an abrasion resistant edge.

Normal Performance. Normally the welds that hold a 5-inch edge to the bucket would break well within 2 months of service and need repair.

Meta-Lax was added during welding. The edges would last at least 10 months in service without any breaking. When repair was needed it was due to the edge being worn off instead of breaking off (as shown). They confidently increased the width of the blade to 8-inches to give even more service life.

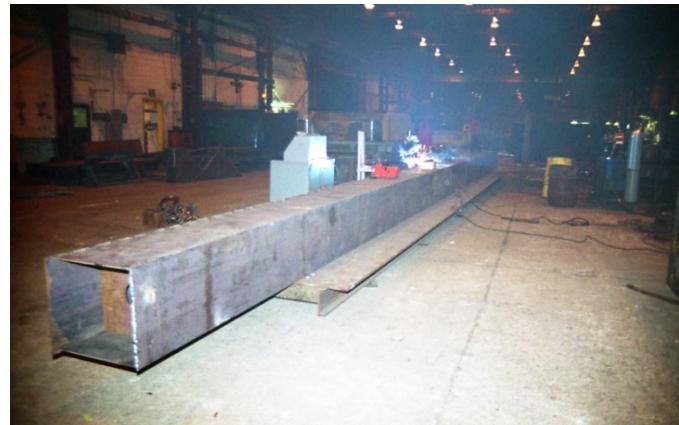
### **#8 Checking Fixture**

Description. Box style checking fixture was used to check airplane wings. Weldment was 20-in. sq. x 50-ft. length.

Normal Performance. Checking fixture distorted 3-inches over the 50-ft. and was scrapped.

Performance Following Meta-Lax Treatment. Meta-Lax was added during the welding process. Distortion was  $\frac{1}{4}$ -inch over the 50-feet length.
